S-12D Flow-way Maintenance

Task Force Meeting
May 18, 2006

S-12D Flow-way Maintenance Pilot Project

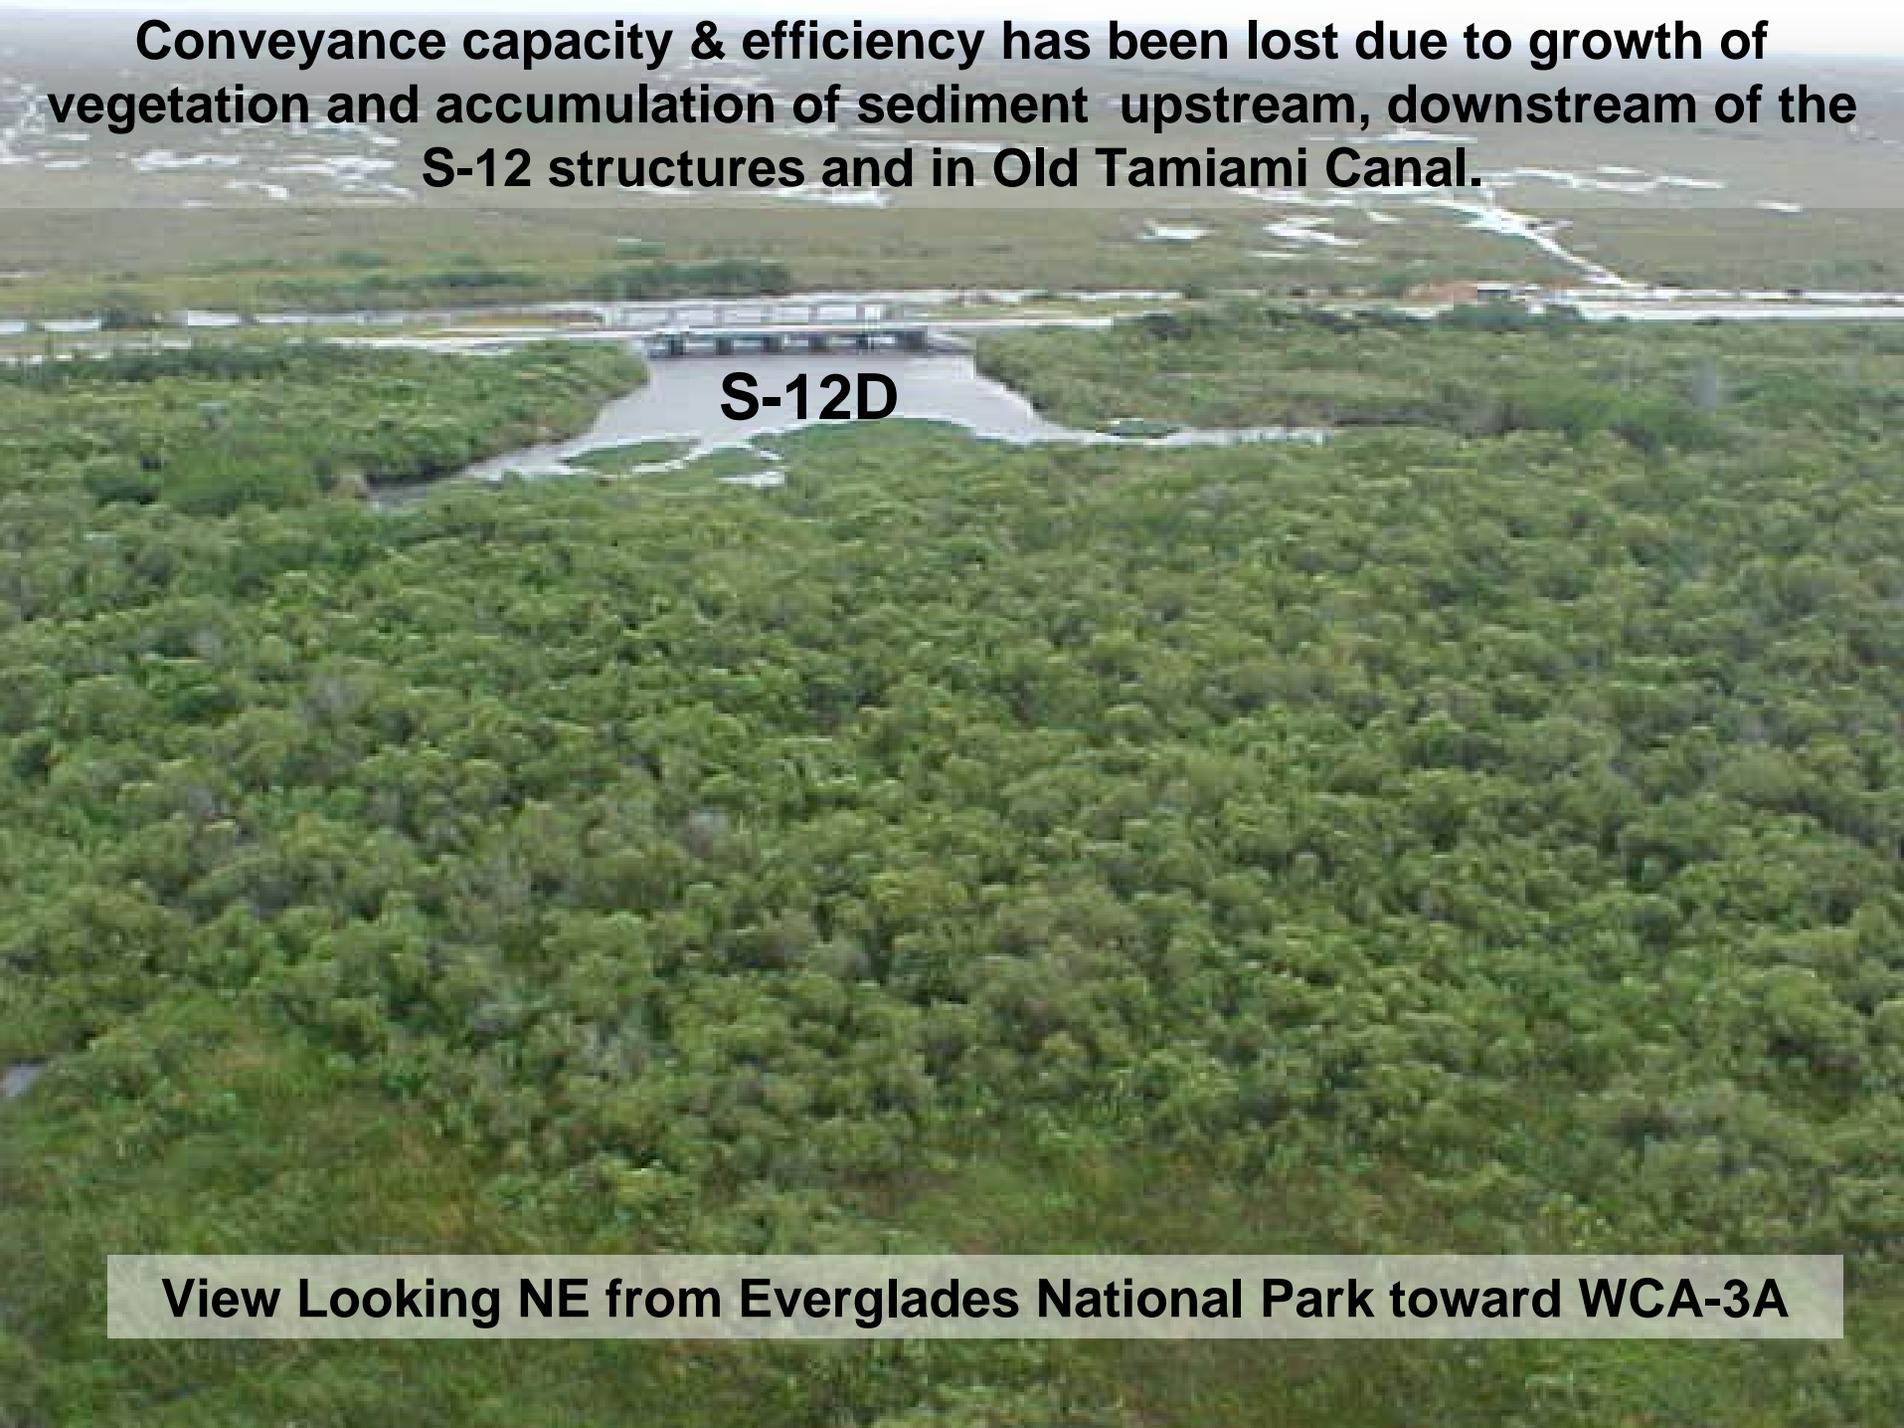
S-12D

Conveyance capacity & efficiency has been lost due to growth of vegetation and accumulation of sediment upstream, downstream of the S-12 structures and in Old Tamiami Canal.

An aerial photograph showing a canal structure labeled 'S-12D' in the center. The structure consists of several rectangular concrete blocks across a waterway. The surrounding area is dominated by dense, lush green vegetation, likely mangroves. In the background, there are some buildings and a road. The overall scene illustrates the impact of vegetation growth on the canal's conveyance capacity.

View Looking NE from Everglades National Park toward WCA-3A

- Vegetation and sediment accumulation in the upstream & downstream flow-way and in the Old Tamiami Canal.
- Flow ratings for the S-12 system, particularly S-12D, indicate reduced conveyance capacity.
- Flow conveyance restriction primarily downstream (tailwater driven).

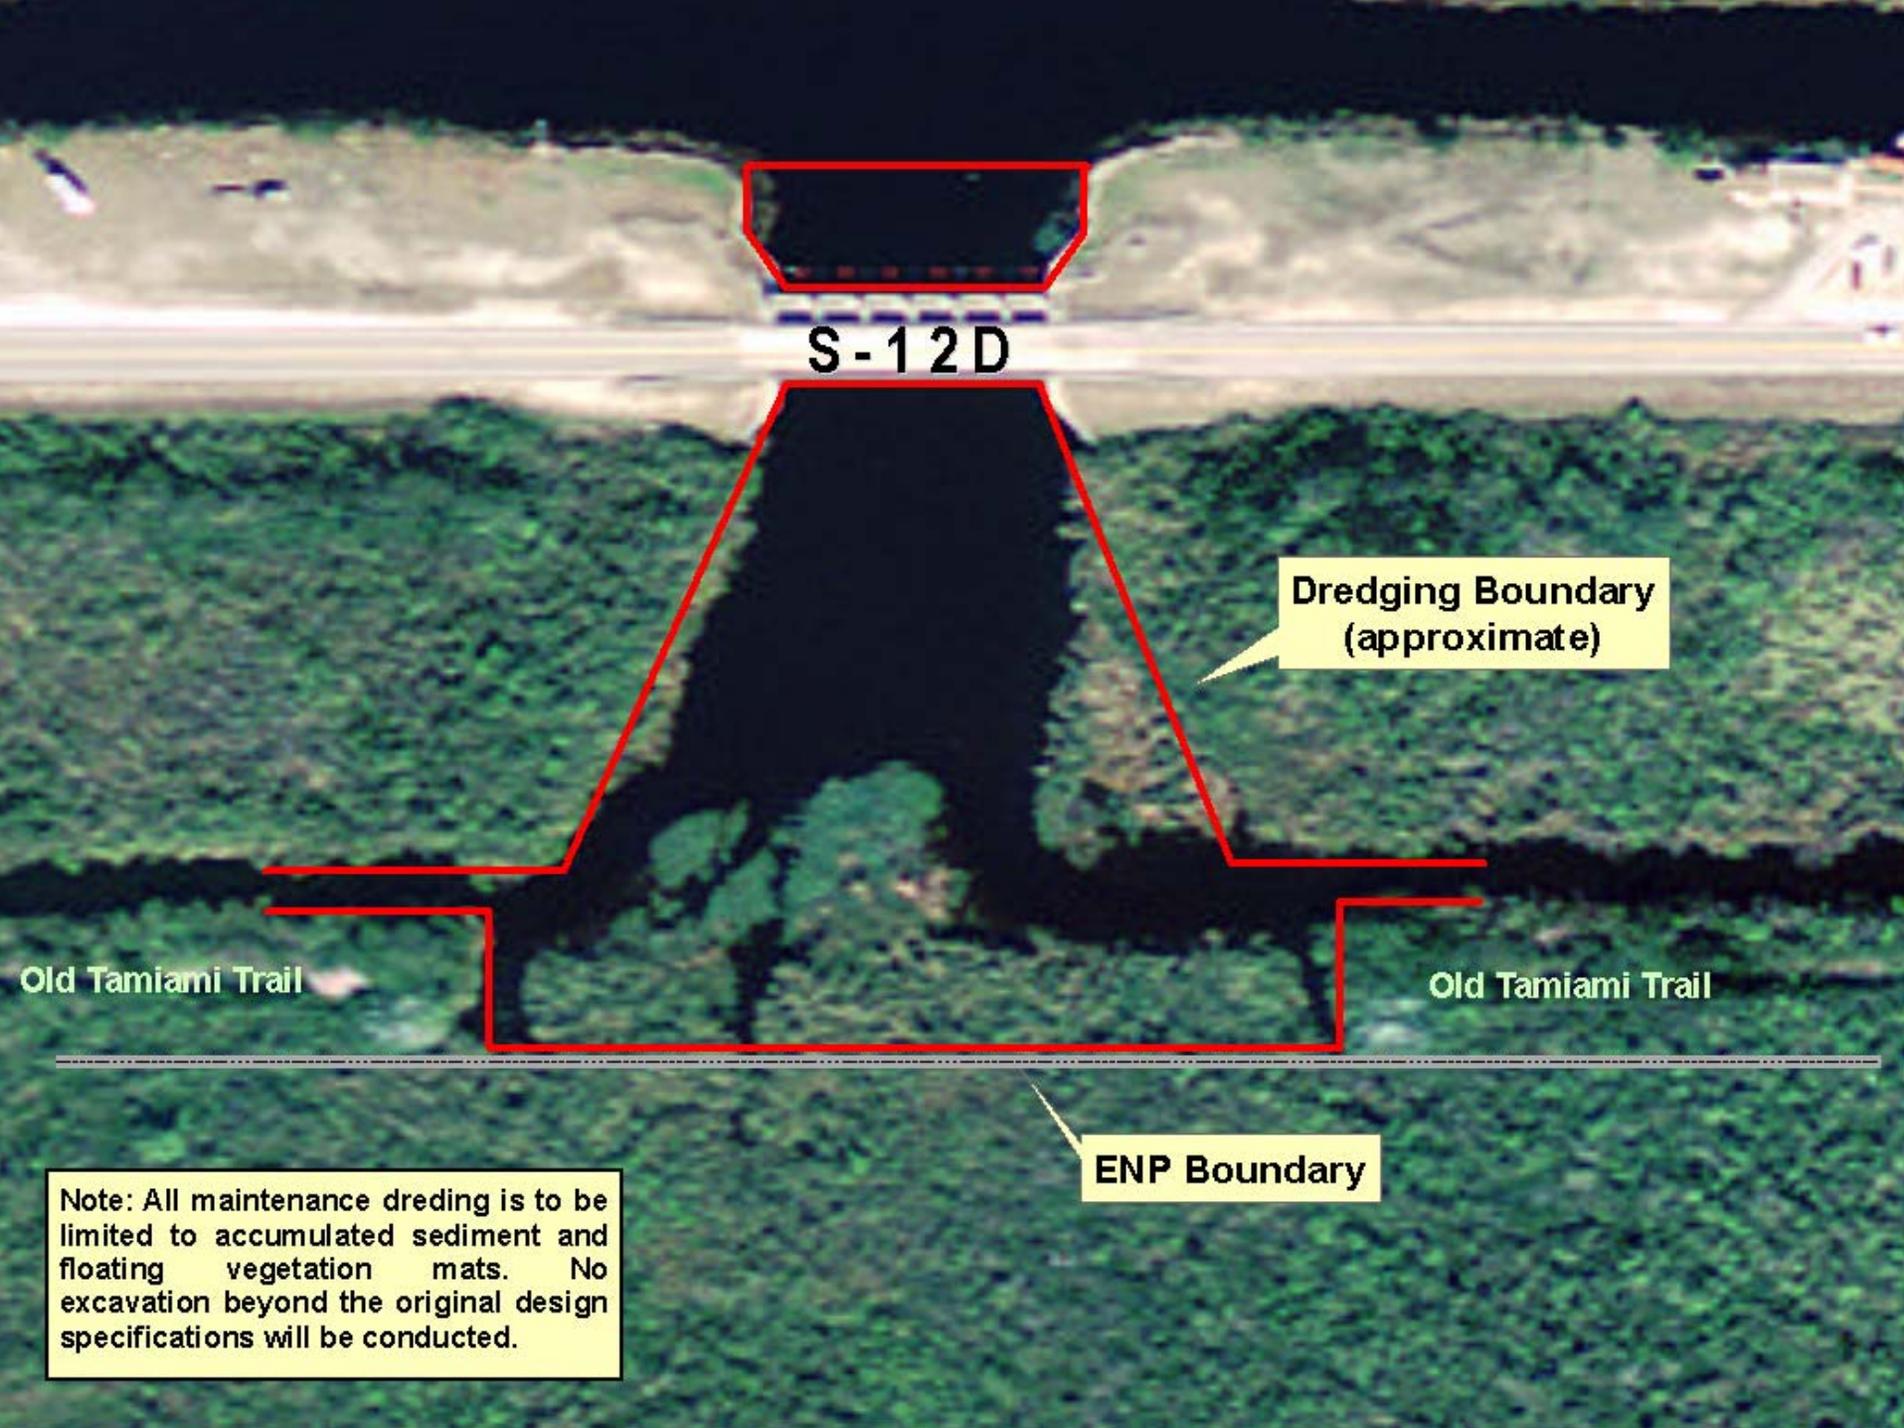
**Dredging Boundary
(approximate)**

Note: All maintenance dredging is to be limited to accumulated sediment and floating vegetation mats. No excavation beyond the original design specifications will be conducted.

- Vegetation and sediment removal at S-12D and the downstream flow-way to the ENP boundary;
- Invasive vegetation control along bank of Old Tamiami Trail from S-346 to the FP&L access road;
- Post-maintenance assessment with recommendations on the feasibility of maintenance at the S-12A, B, & C structures.

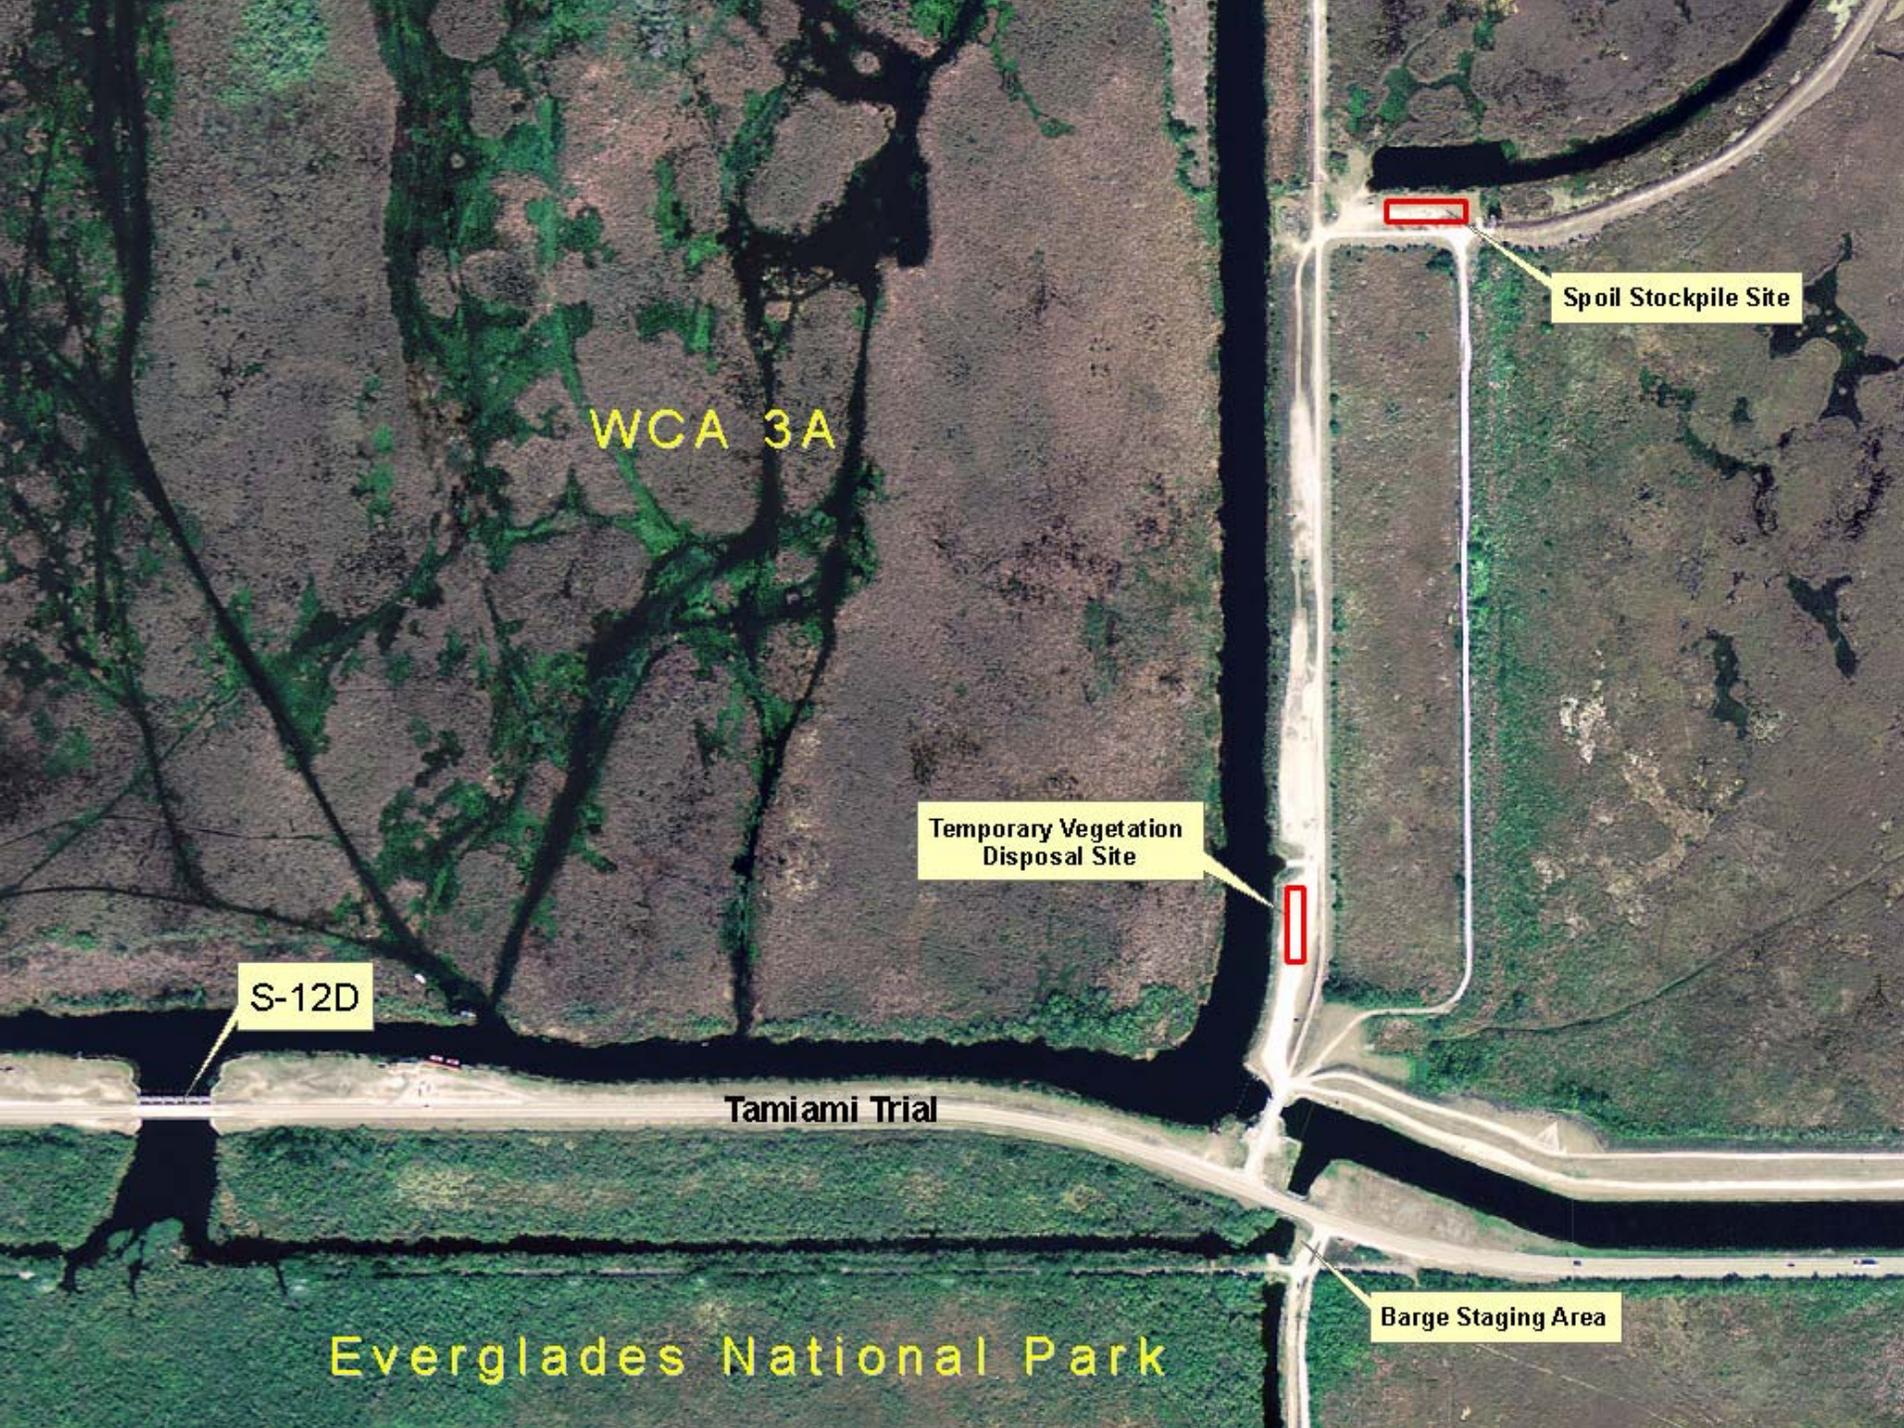
Spoil Stockpile Site

Temporary Vegetation Disposal Site

Barge Staging Area
